1. Report No. MN 2021-XX	2.	3. Recipients Accession No.	
4. Title and Subtitle Drive MN Final Report		5. Report Date [Month 2021X]	
		6.	
7. Author(s) Ross Tillman, Chloe Weber, Ashley Hudson		8. Performing Organization Report No.

Drive MN

Final report

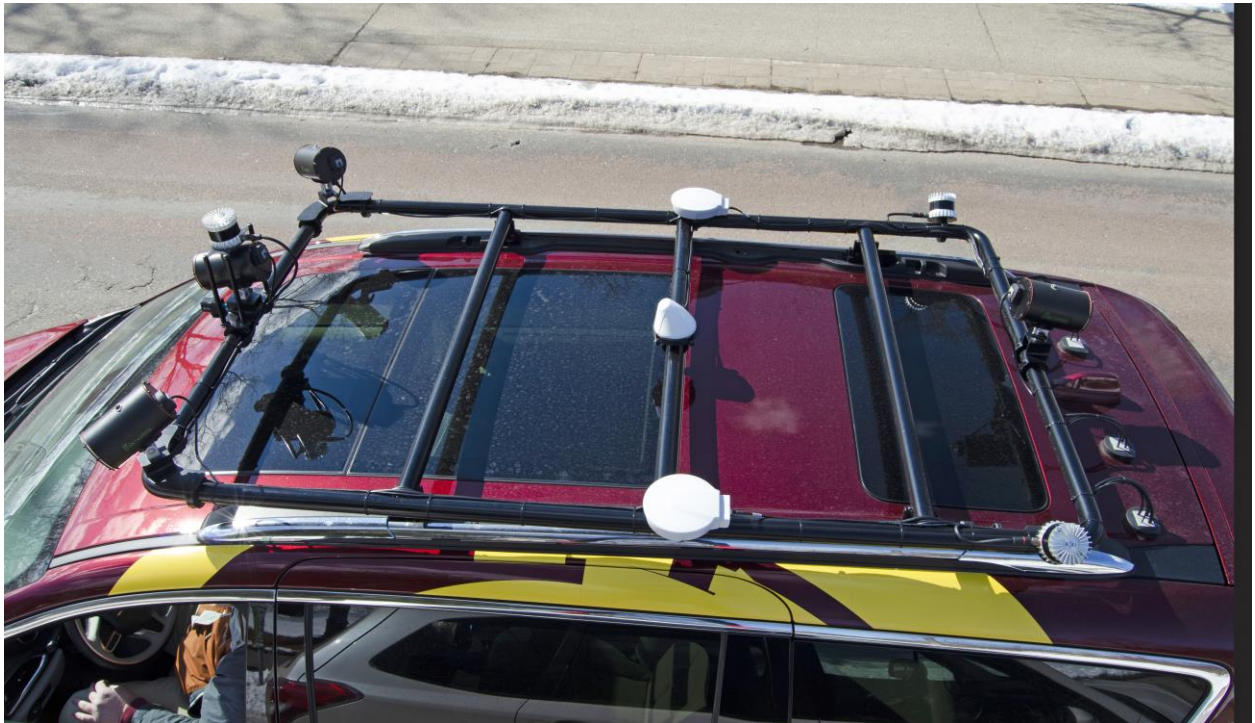
Figure 11 - Image of Vehicle 2 Top Rack

Vehicle 2 (Figure 11)

- (1) 64-channel Outser LiDAR
- (2) 16-channel Ouster LiDARs
- (4) Blackfly video cameras
- (1) FLIR ADK thermal camera
- (2) Conti Radar
- (1) Novatel GNSS receiver
- (1) Neousys Nuvo computer

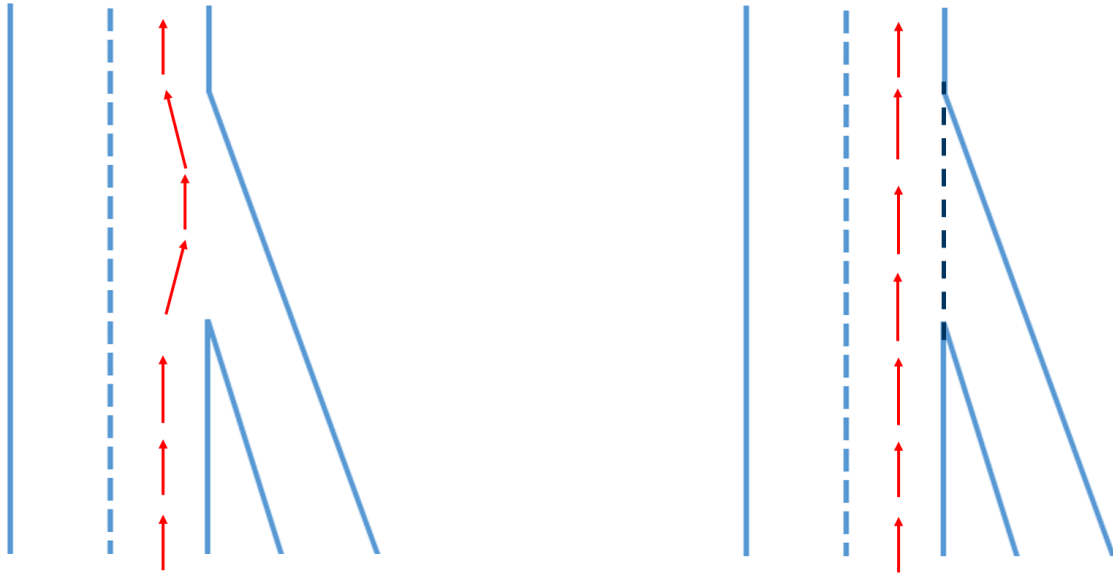
Figure 14 - Entrance Ramp Diagram (Undesirable Vehicle Path on Left, Desired Vehicle Path on Right)

When driving in the right-most lane, a vehicle is adjacent to an exit ramp, entrance ramp, or turn lane. These features include a mixing area where vehicles are entering or exiting the major roadway that can either have a delineation marking the major roadway edge or no marking. When vehicle automation relies on striping to the left and right of the travel path, this lack of striping may cause a misdetection, potentially causing the vehicle to follow an incorrect path despite driver and route intentions. **Figure 14** and **Figure 15** show desirable and undesirable vehicle paths on entrance and exit ramp configurations to illustrate this issue.

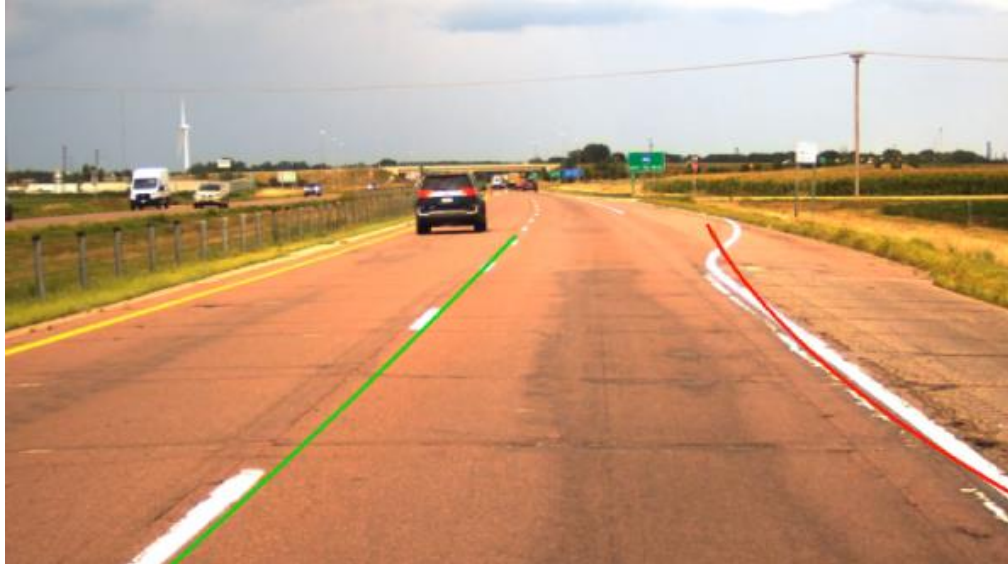
Figure 16 - Misdetection of Lane Due to Unstriped Diverge Area

As seen in **Figure 16**, the unmarked area between the right driving lane and the turn lane causes the sensor to assume the driving lane continues into what is actually the turn lane (the red line). **Figure 17** shows how the continuous marking leads to the proper delineation of a turn lane which allows the sensor to distinguish the edge of the current driving lane (red) and the edge of the turn lane (purple).

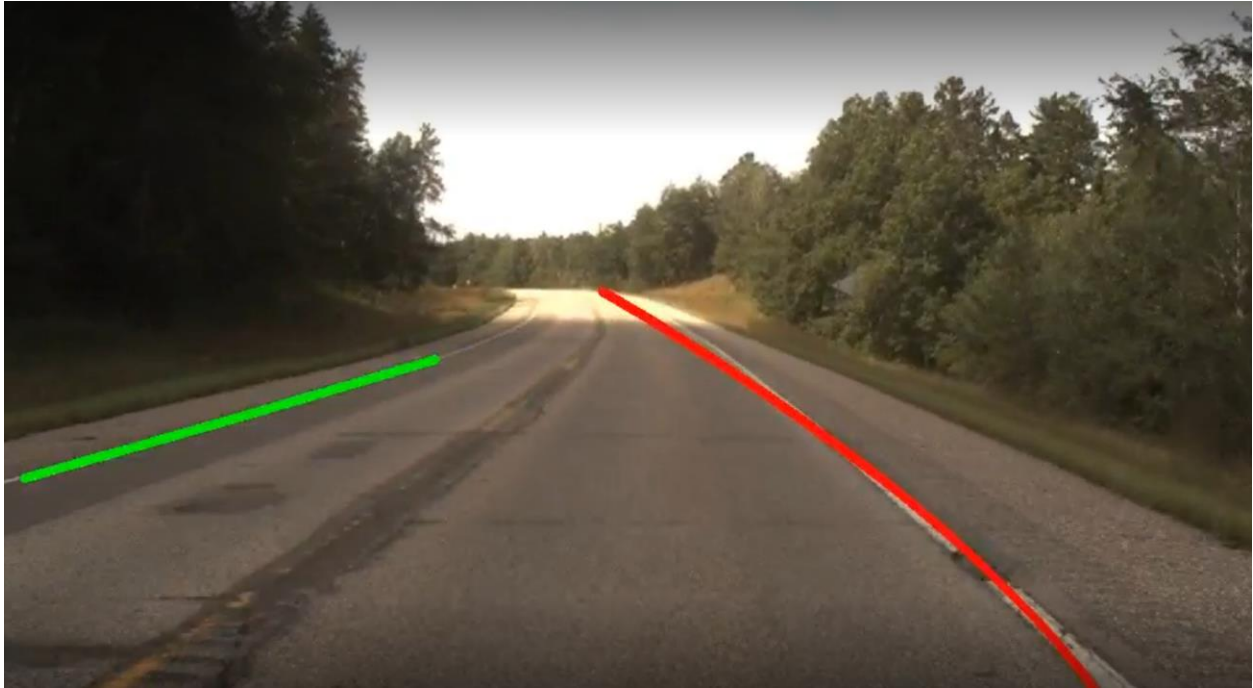
Figure 18 - Example of Poor Lane Line Visibility

Various conditions may contribute to poor centerline visibility on the roadway. Deteriorating pavement, chipped or faded markings, or pavement repairs can make it difficult for the vehicle's equipment to properly place the edge line, as seen in **Figure 18**. Therefore, the system believes the outside edge of the driving lane is the edge of the opposite direction's lane (green). This could cause the vehicle to veer into the oncoming driving lane while centering itself in its intended driving lane.

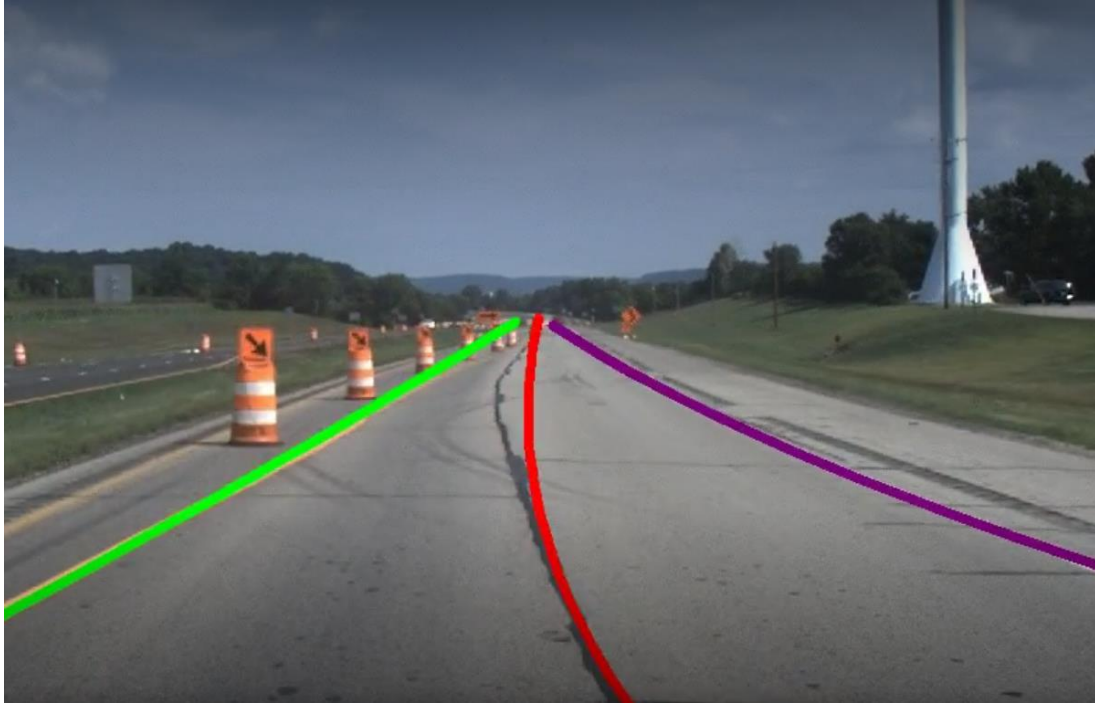
Figure 20 and **Figure 21** show construction zones on multilane highways. In both cases, there are misdetections due to existing markings on the roadways from prior maintenance, masked existing markings, or tire marks.

Figure 20 - Misdetection Due to Crack Seal

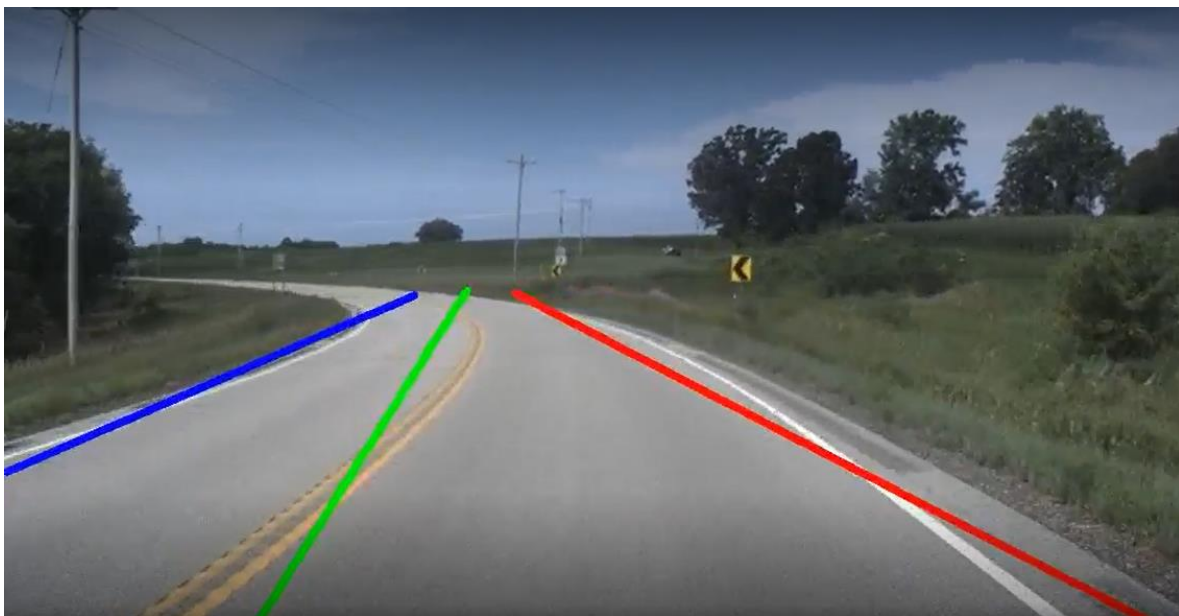
In some cases, the horizontal curvature of the roadway was too tight for the system to properly fit lane lines, potentially causing misdetections or poor performance. **Figure 25** shows an example of this. These situations may be unavoidable from a design perspective given the context of many roadways, meaning either more sophisticated/fine-tuned algorithms are needed or high-definition mapping would be required for smooth performance. Most automated driving functions on the market today do not work well in tight curvature situations for the following reasons:

- Camera may not have a wide field of view
- The algorithms are optimized for highway lane keep assist or autopilot applications

Figure 25 - Example of Tight Curvature Causing Poor Performance

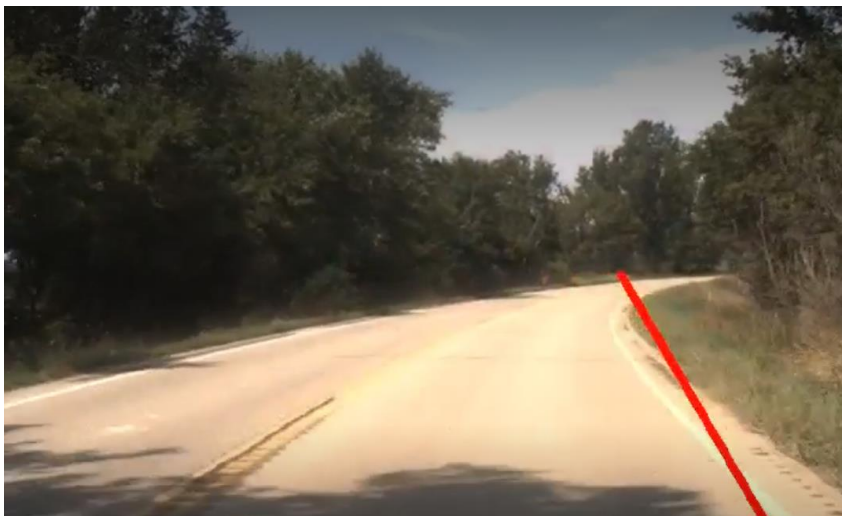
Figure 27 - Especially Sunny Area Makes Marking Indistinguishable

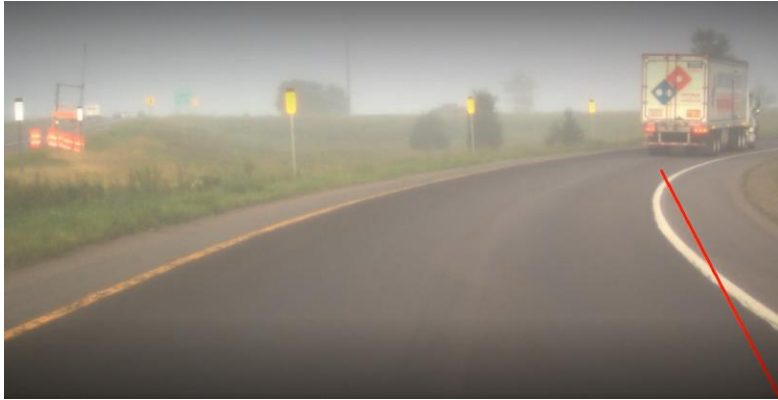
One instance of fog was experienced during the drive. As shown in **Figure 28**, it was dense enough to cause detection issues on an exit ramp. The frame of video used shows only right edge line partial detection, although on the majority of other frames neither edge line was detected.

Figure 28 - Poor Sensor Performance in Fog

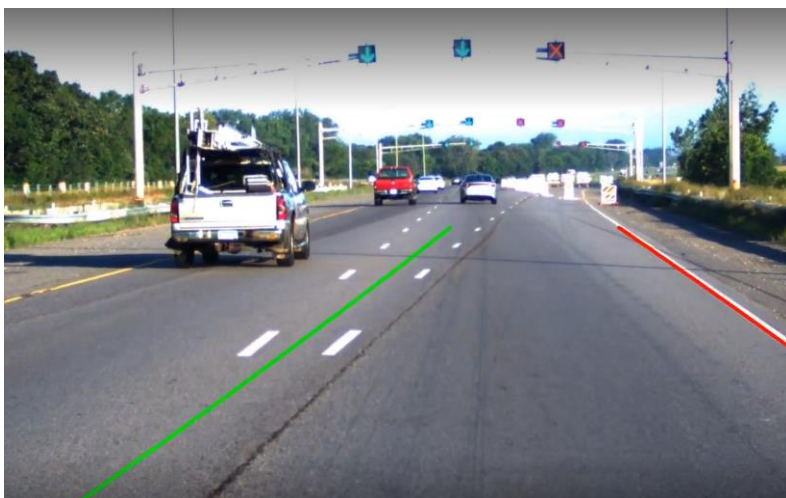
A unique feature in Minnesota is the MnDOT MnROAD facility on I-94 between Albertville and Monticello. There are lane markings leading to both roadways, though only one is ever open at a time. Human drivers can distinguish between the path they need to take by using the overhead signals as well as road barriers. However, an automated vehicle may not have the capability to distinguish or choose. The vehicle responded and connected with the lanes as shown in **Figure 29**, which may incorrectly cause the vehicle to attempt to take the rightmost lane. This situation could also arise on other highway splits/merges or in other areas with dynamic lanes and shoulder uses. The behavior demonstrated in **Figure 29** may cause an unintended exit or crash depending on other traffic in the area.

Figure 29 - MnROAD Lane Closures May Cause Misdetection
